# Manhole Inspection Summary

Manhole # S13MM\_007MH

Insp Date: **2/20/09 1:04 PM**

**Location** Address: **ELGIN AVE**

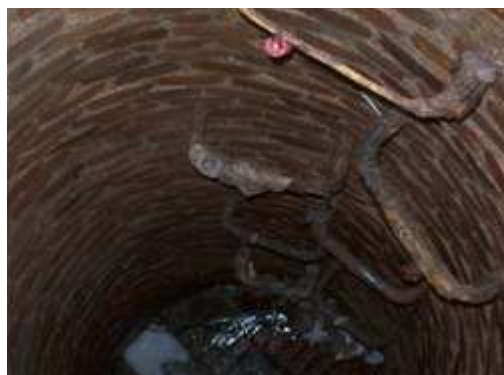
Defect 2

**Steps** Count: **10** Missing: **0** ☒ **Corroded**

**Surcharge** ☒ **Evidence Of Surcharge** Depth: **4** (ft.) ☐ Active Surcharge Present

EVIDENCE OF SURCHARGE AND  
CORRODED STEPS

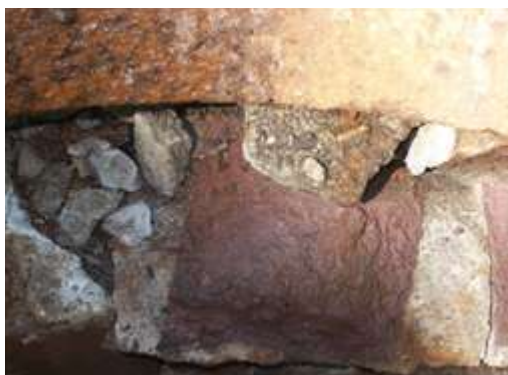
Defect 1

Condition: ☐ Sound ☒ **Cracked** ☐ Root Intrusion ☒ **Loose Brick** ☐ Deteriorated

CHIMNEY/FRAME ADJUSTMENT  
CRACK/LOOSE BRICKS

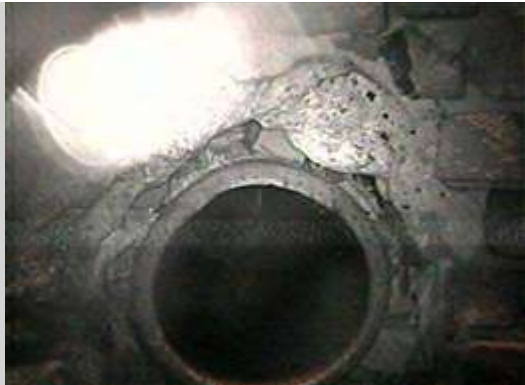
6 O'Clock Inflow

Infiltration: **None** Pipe Seal Cond: **Cracked**
